# PROGRESS REPORT

PR 91565-430-8

For the Period of February 15, 1963 - March 15, 1963

DEVELOPMENT OF AUXILIARY ELECTRIC POWER SUPPLY SYSTEM

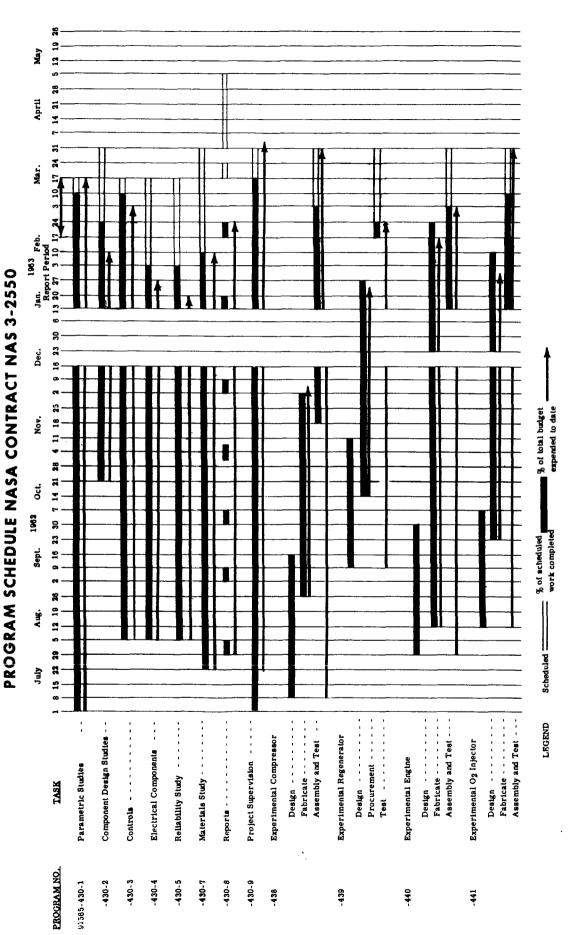
Fig. 1

The program schedule is shown in Fig. 1. The schedule has been extended to take advantage of a 30 day extension which was agreed to by NASA and Vickers personnel January 17, 1963. It is expected that completion of the program can be accomplished in accordance with the revised schedule shown in Fig. 1.
